U.S. AIR FORCE
INSTALLATION RESTORATION PROGRAM .
PHASE I: RECORDS SEARCH

AIR NATIONAL GUARD, CAMP EDWARDS (ARNG),
U.S. AIR FORCE AND VETERAN'S ADMINISTRATION
FACILITIES AT MASSACHUSETTS MILITARY
RESERVATION, MASSACHUSETTS

FINAL REPORT: TASK 6

DECEMBER 11, 1986

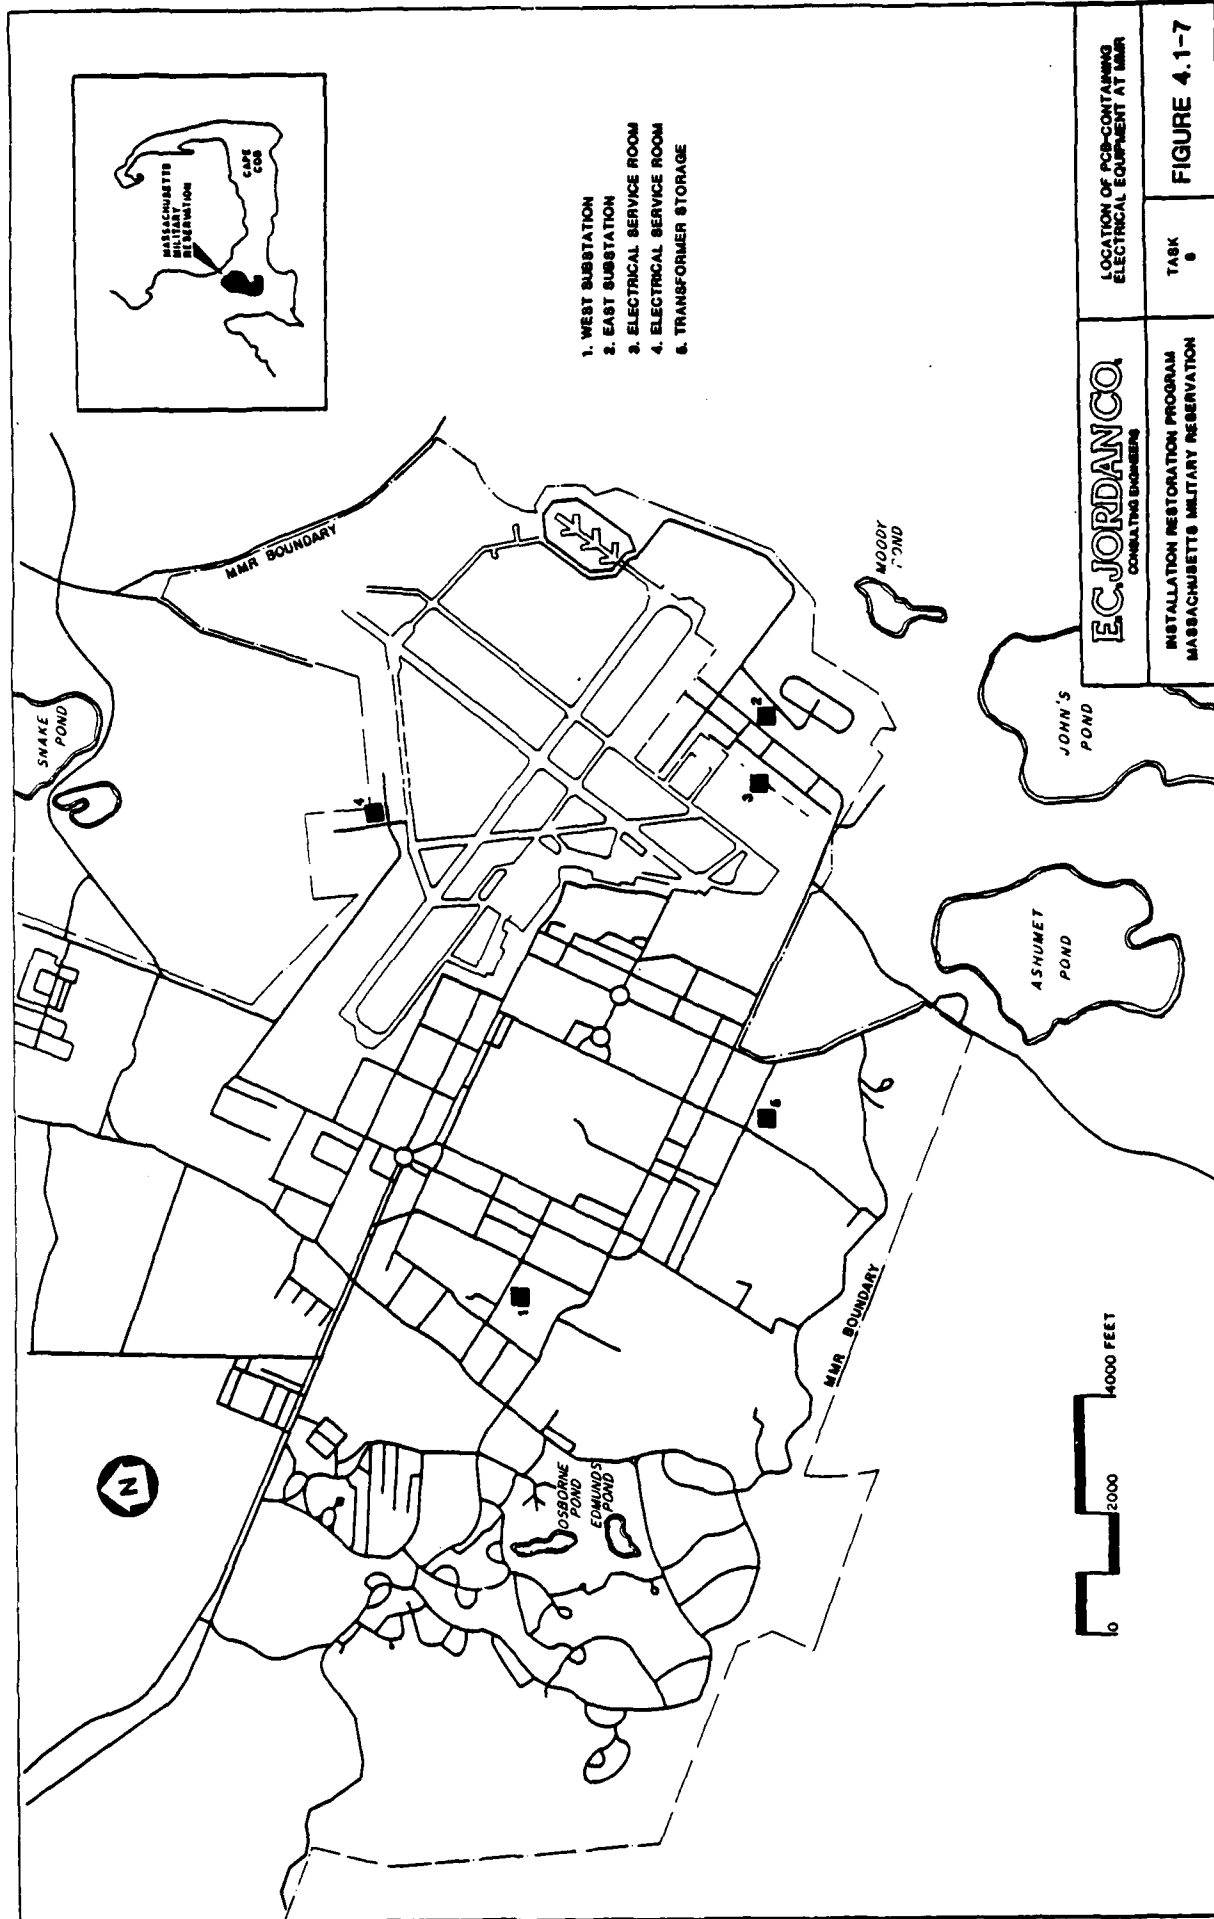
LOCATION OF PCB-CONTAINING
ELECTRICAL EQUIPMENT AT MMR

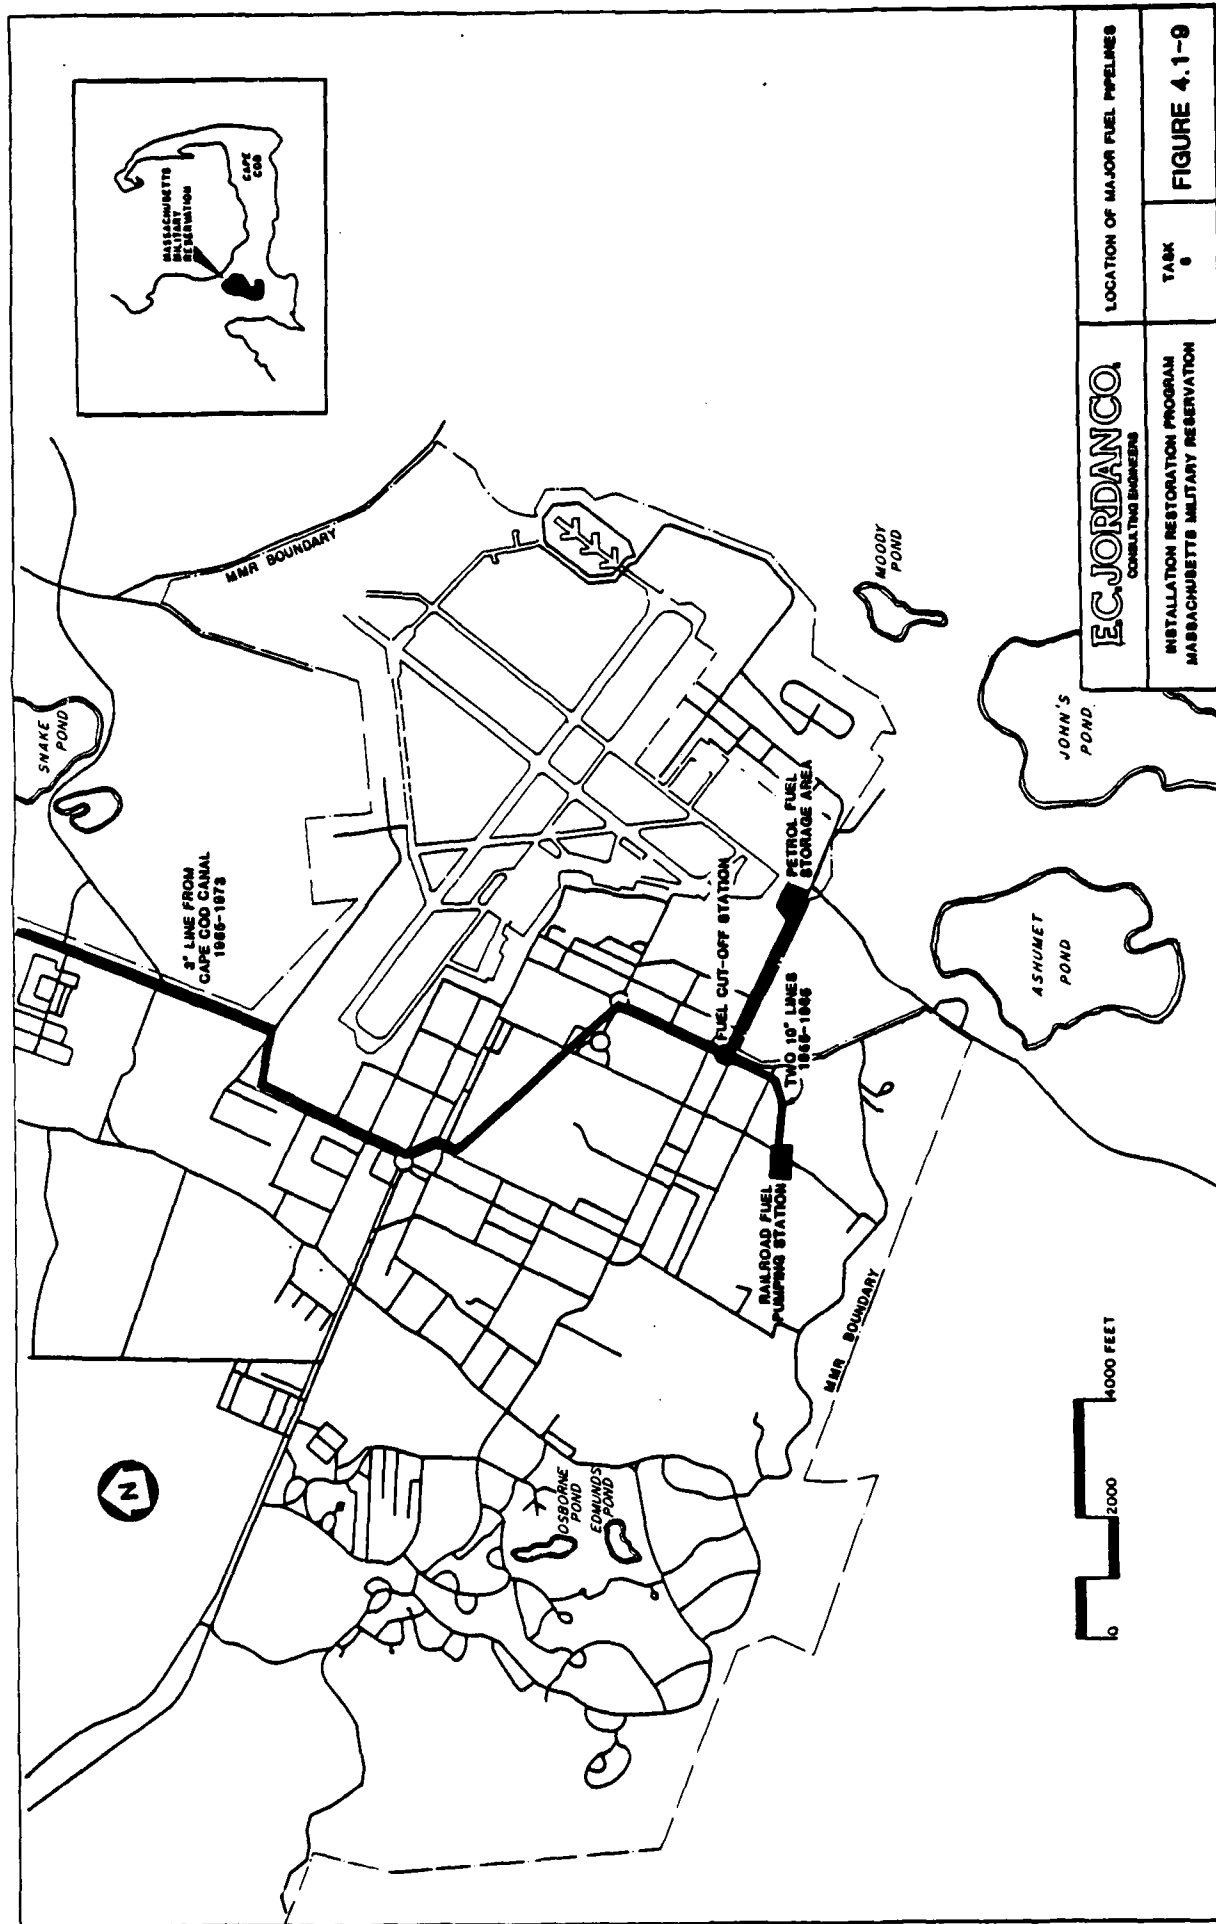
LOCATION OF MAJOR FUEL PIPELINES

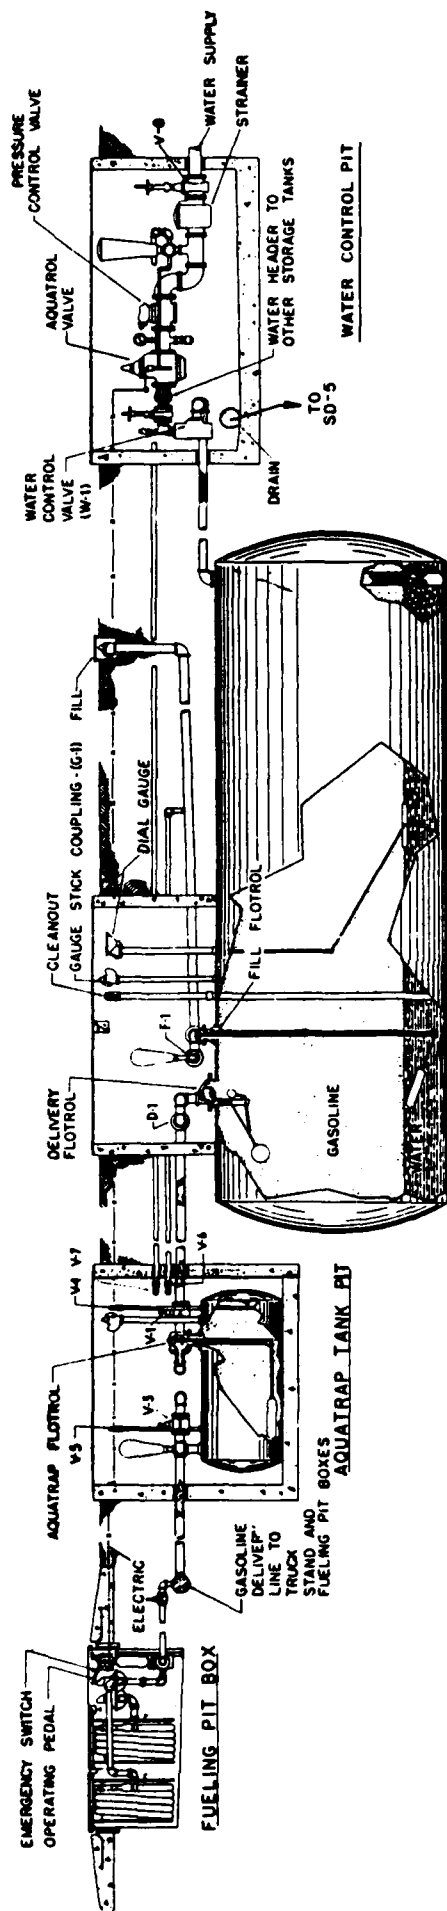
GASOLINE STORAGE TANK

The former ARNG MOGAS fuel storage and transfer point is located at the 3400 Block along Lee Road (see Figure 4.1-8). Six 10,000-gal underground tanks were installed here in 1941. This facility was used to refuel vehicles used on Camp Edwards. These six tanks were removed in 1985. These tanks were found to be in good condition with no evidence of leakage.

The ARNG currently operates two fuel transfer points for the purpose of refueling vehicles used during training activities in the range area. The refueling takes place at the 3500 and 3600 Blocks (see Figure 4.1-8). At the 3500 Block, fuel transfer is usually between the larger tankers (10,000 gal) to the

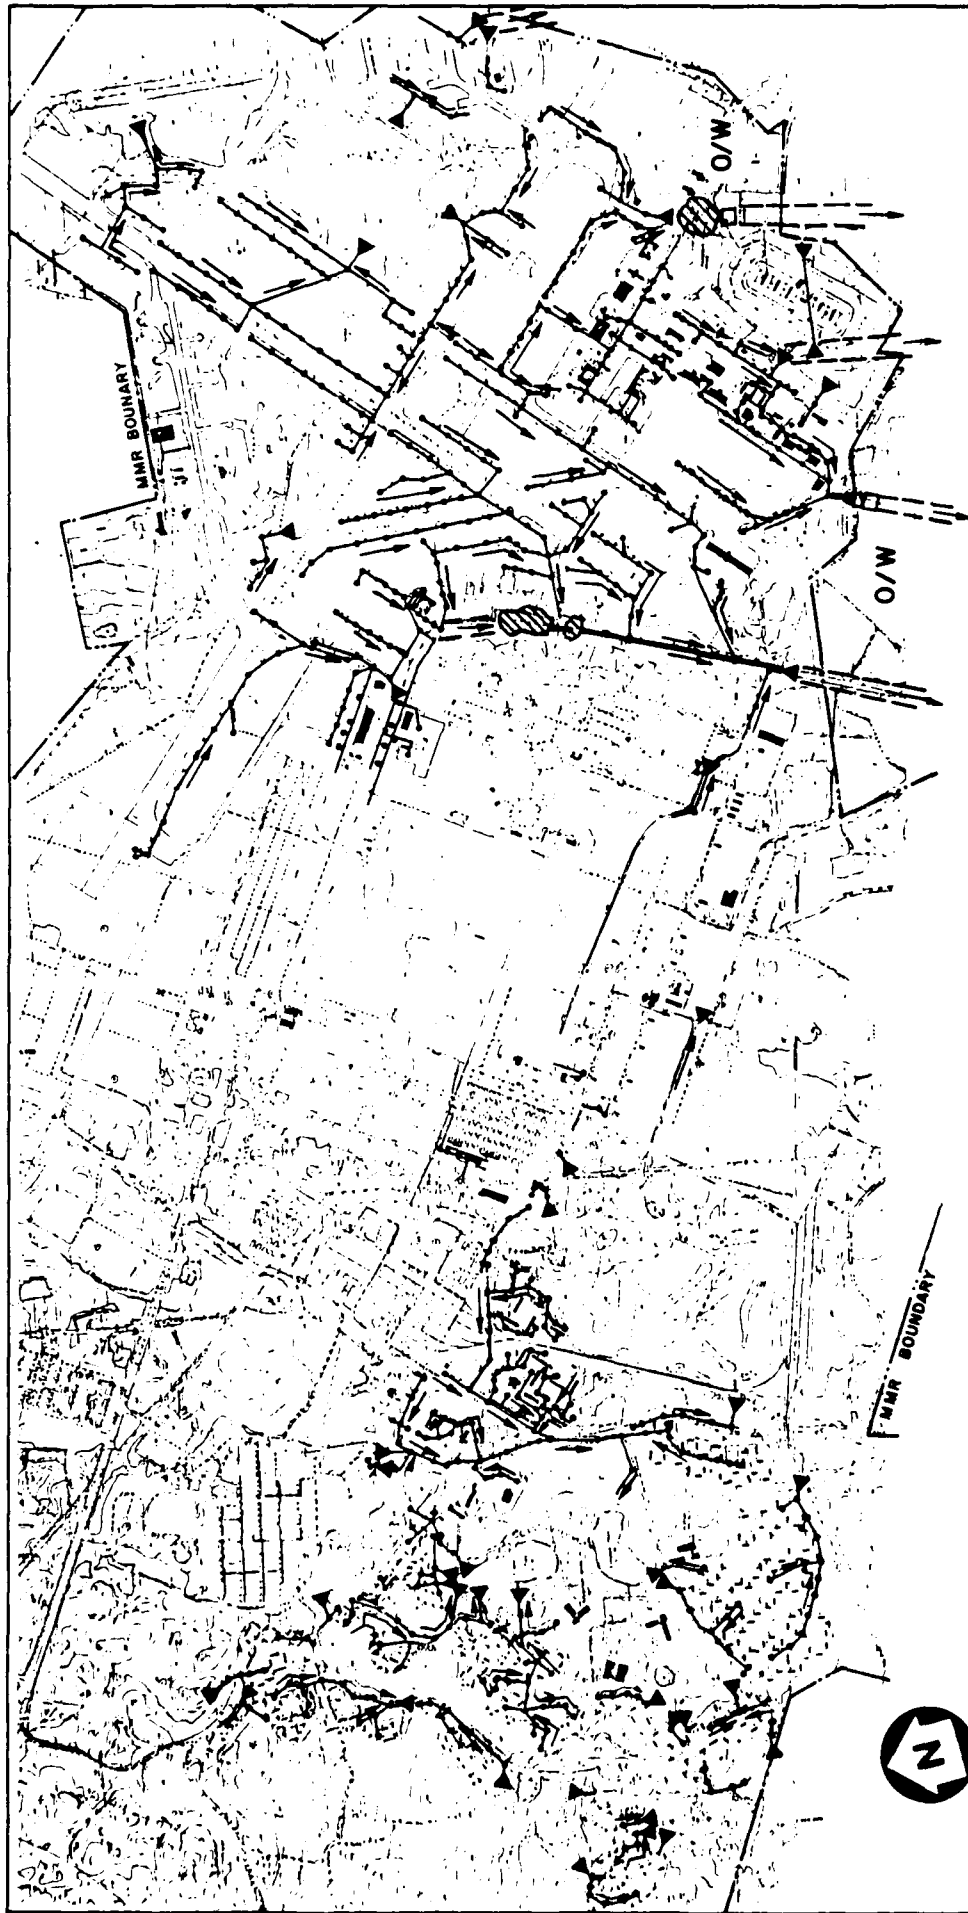
- LEGEND**
- AREA INLET
 - STORM DRAIN LINE
 - FLOW DIRECTION
 - OUTFALL
 - DITCH WITH INTERMITTENT FLOW
 - RUNOFF IMPOUNDMENT OR SWALE
 - O/W OIL / WATER SEPARATOR

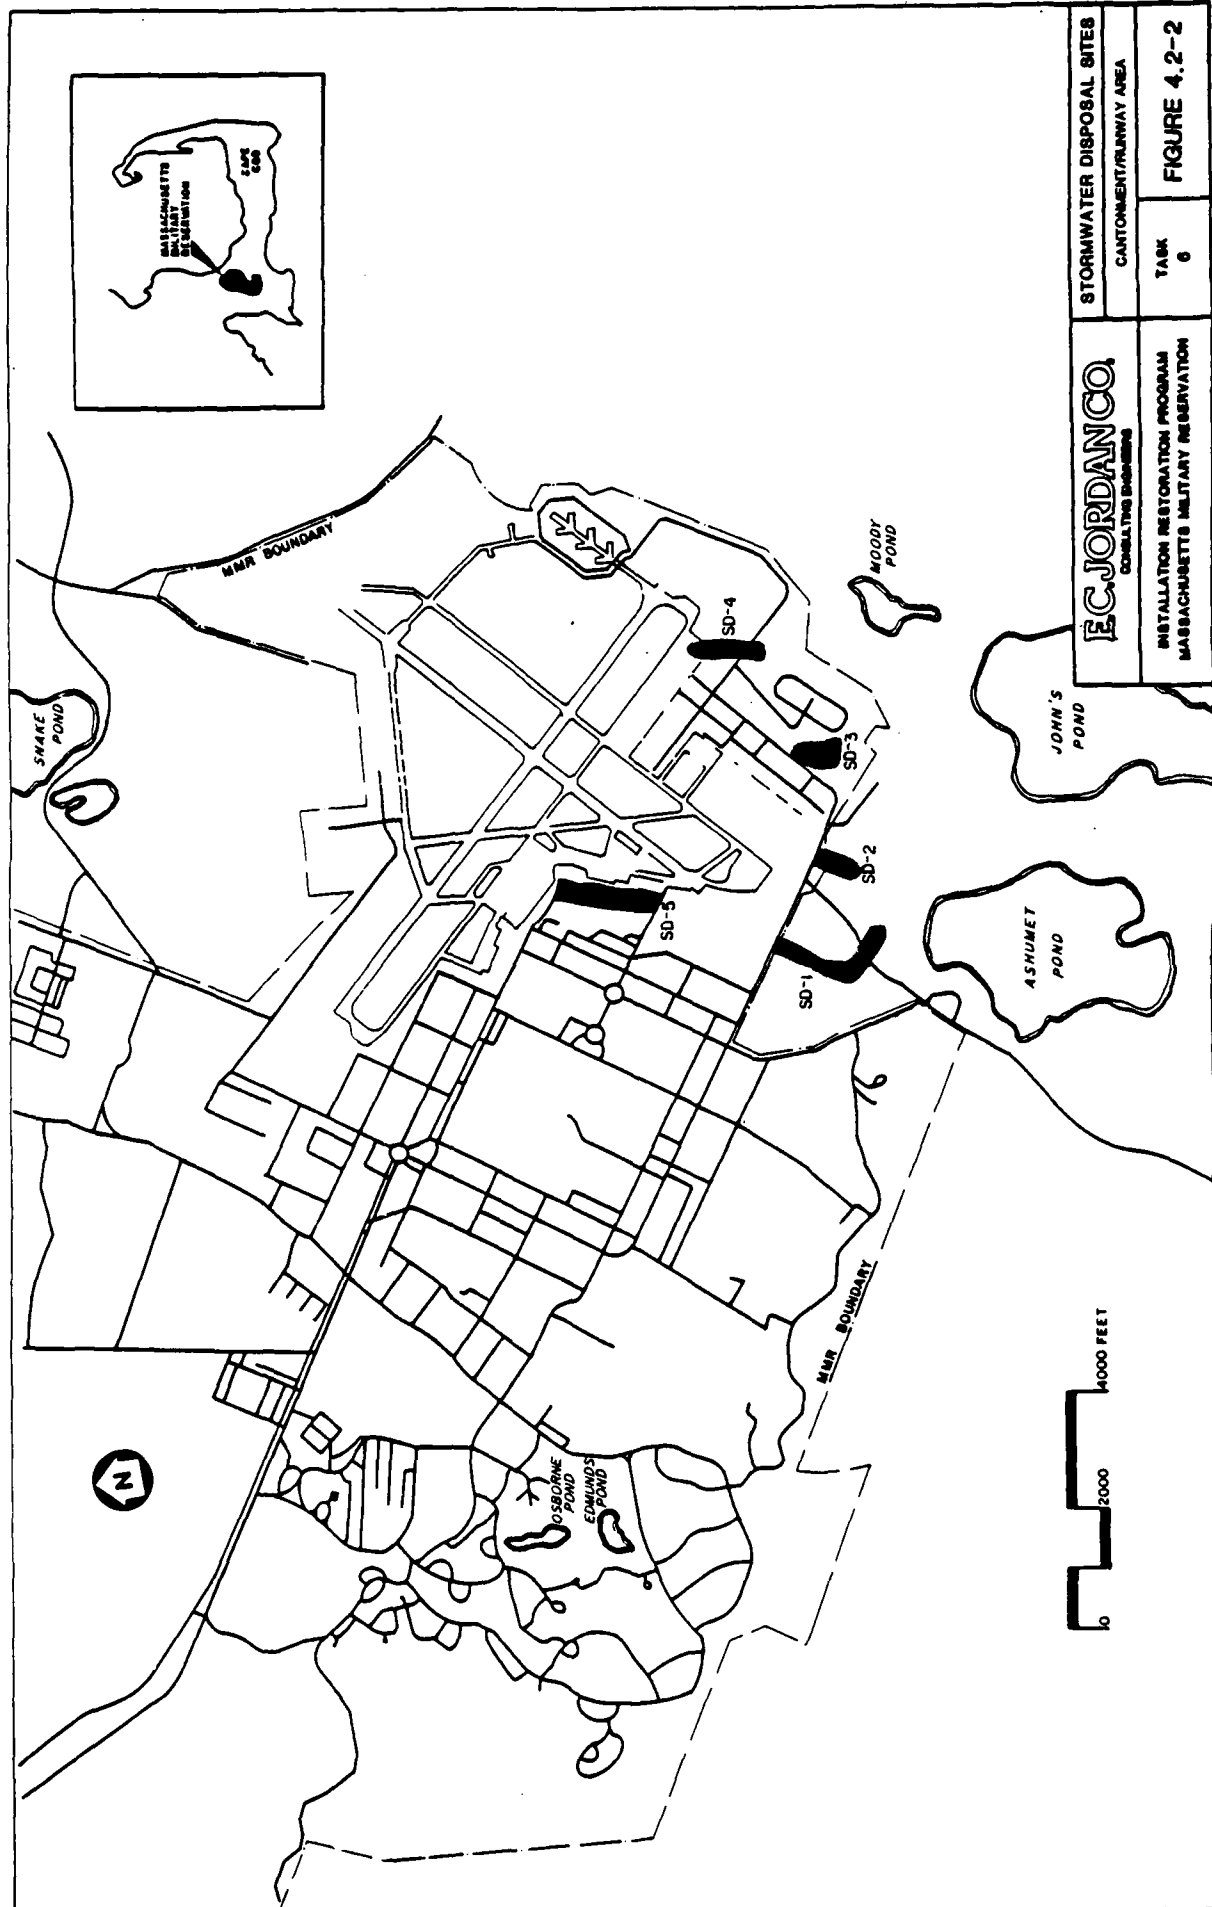
EC JORDAN CO. CONSULTING ENGINEERS	STORMWATER DISPOSAL SITES	
	CANTONMENT/RUNWAY AREA	
INSTALLATION RESTORATION PROGRAM MASSACHUSETTS MILITARY RESERVATION	TASK	6
	FIGURE 4.2-2

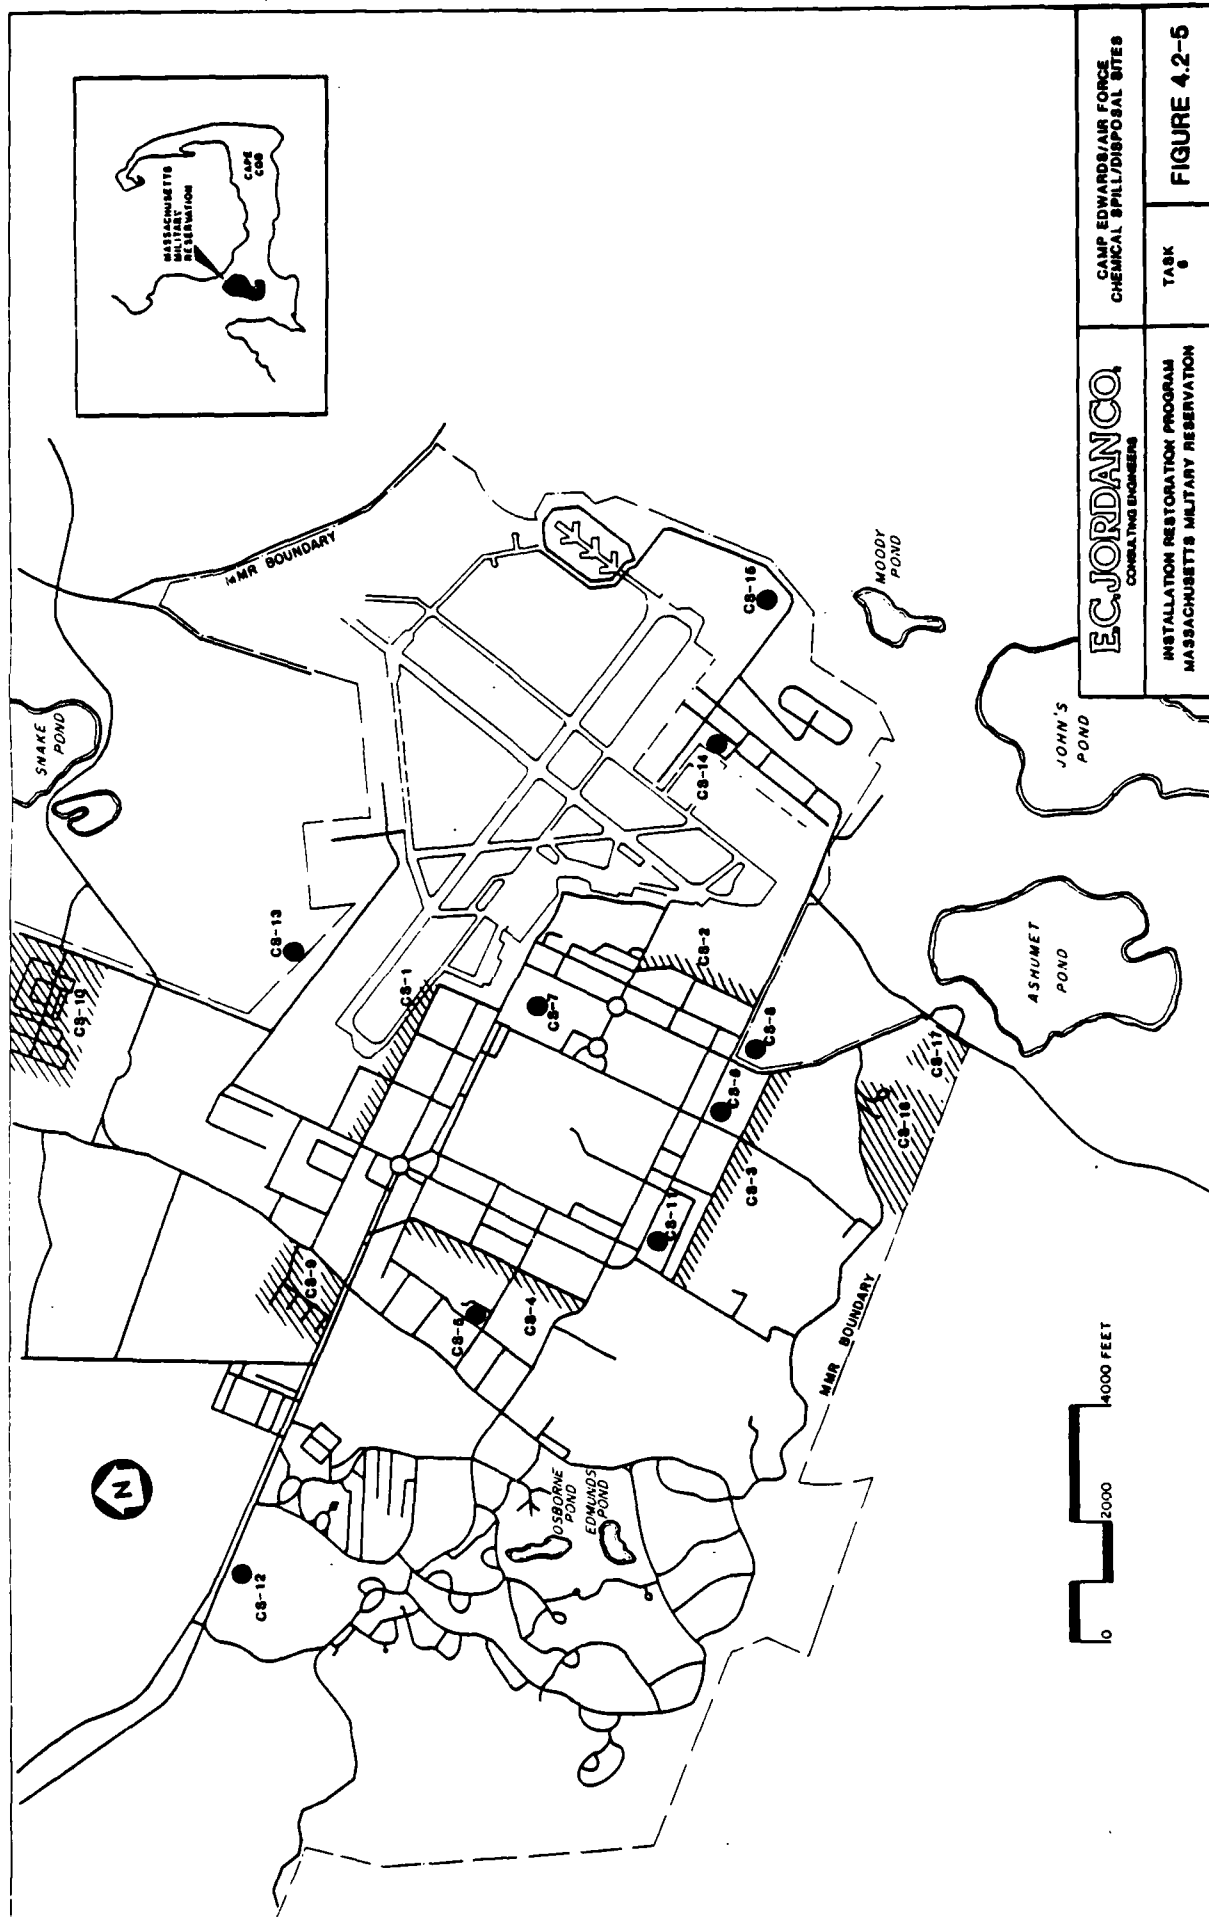
EC JORDAN CO. <small>CONSULTING ENGINEERS</small>	CAMP EDWARDS/AIR FORCE CHEMICAL SPILL/DISPOSAL SITES
INSTALLATION RESTORATION PROGRAM MASSACHUSETTS MILITARY RESERVATION	TASK 6
FIGURE 4.2-5

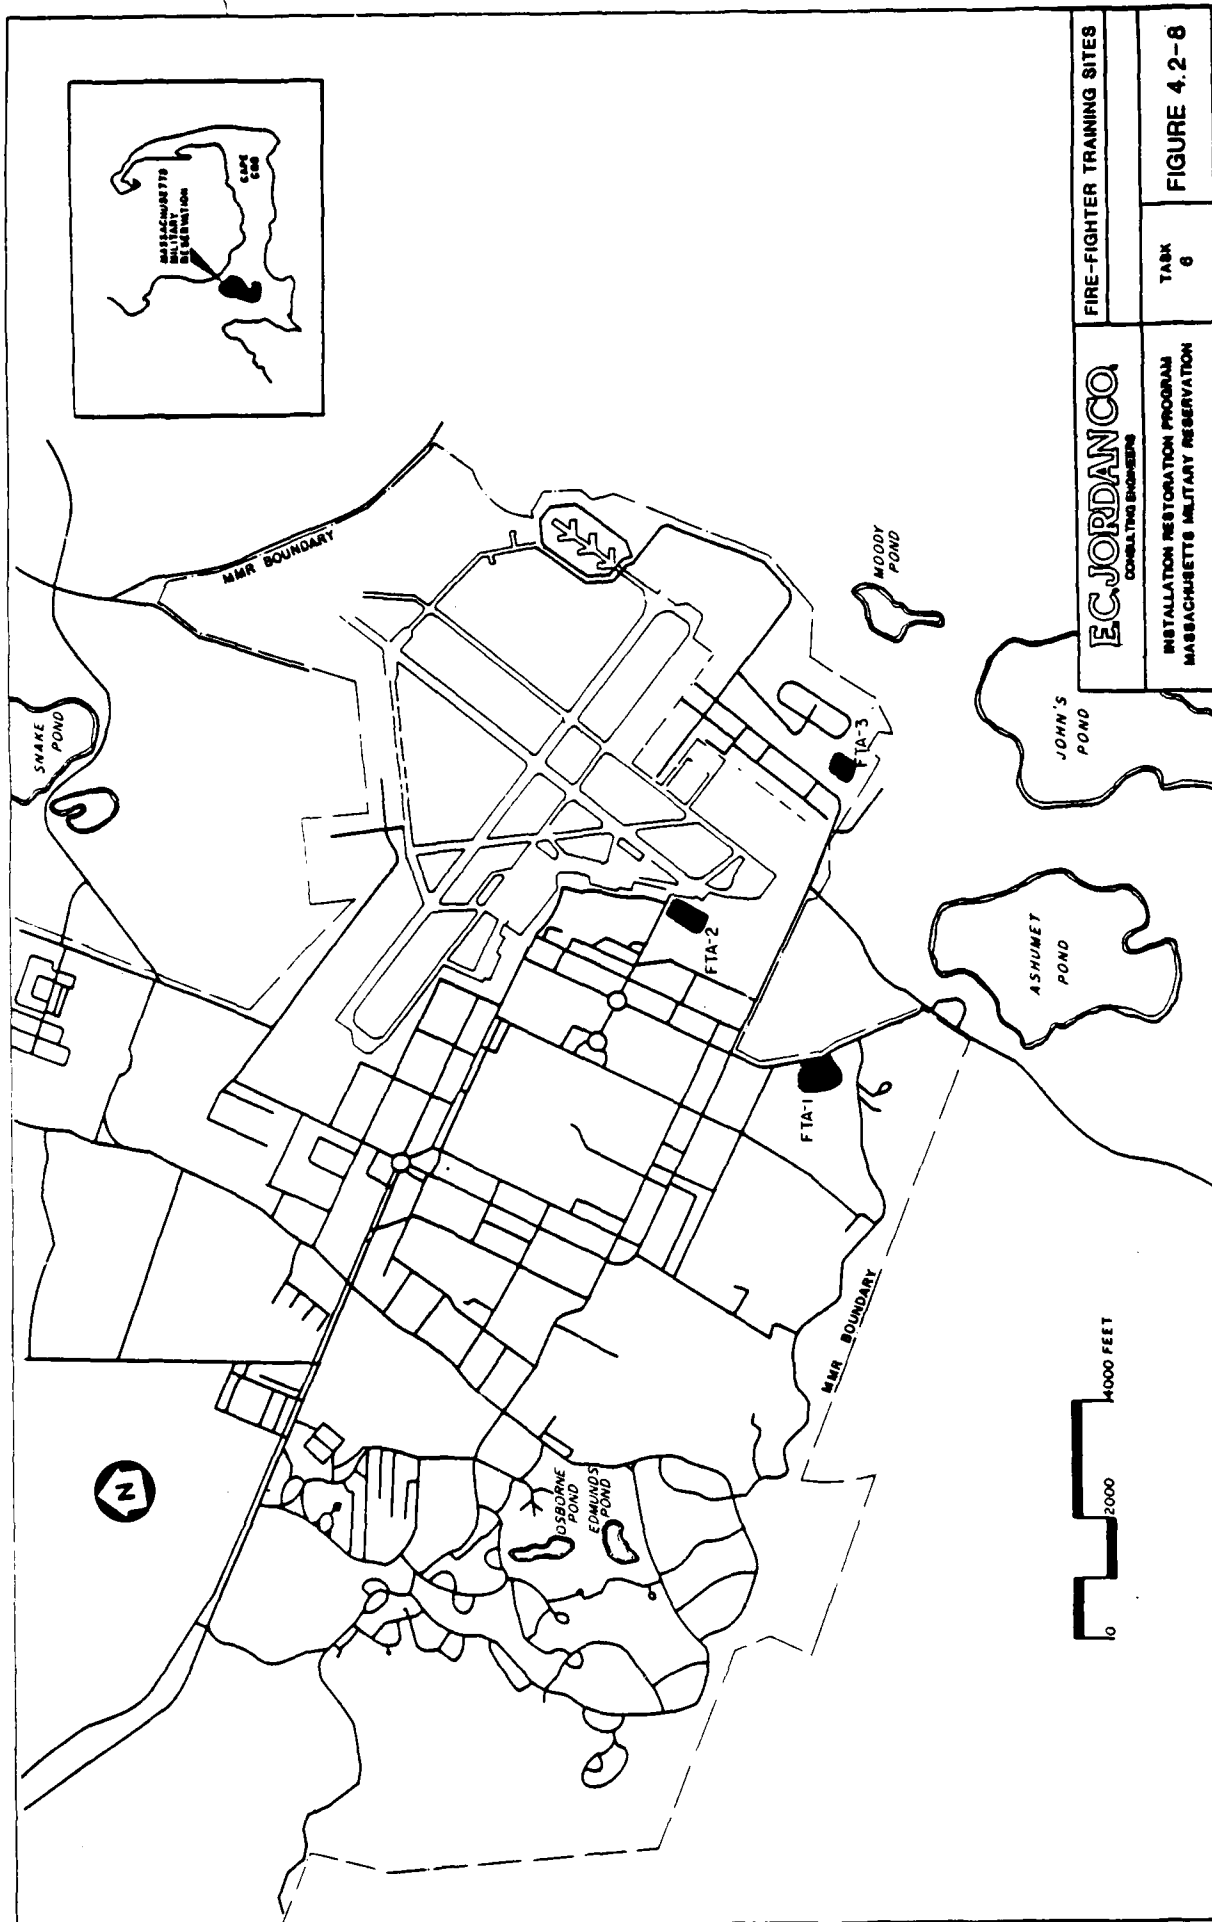
EC JORDAN CO. CONSULTING ENGINEERS		FIRE-FIGHTER TRAINING SITES	
INSTALLATION RESTORATION PROGRAM MASSACHUSETTS MILITARY RESTORATION		TASK 6	FIGURE 4.2-8

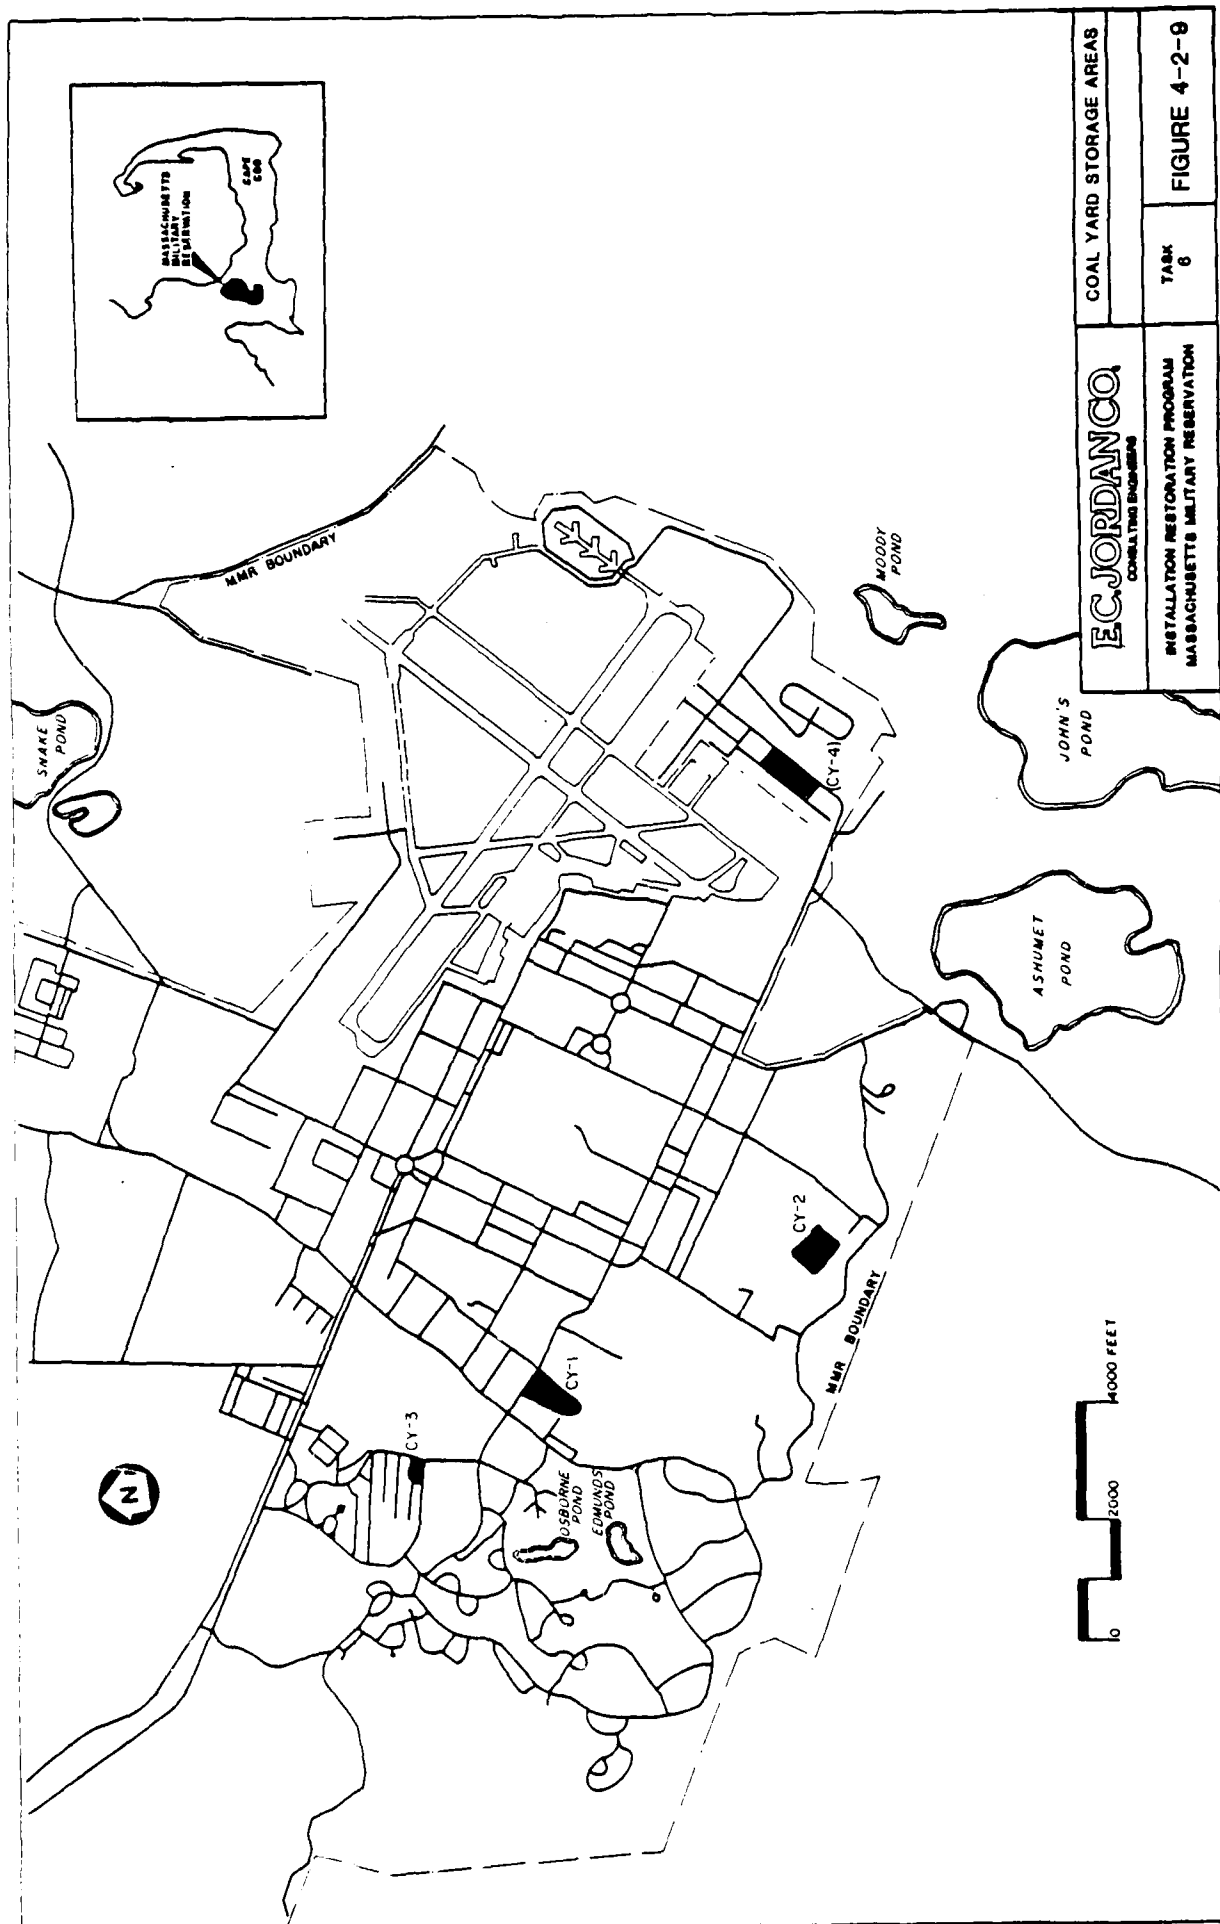
COAL YARD STORAGE AREAS	
EC JORDAN CO. CORRECTION ENGINEERING	
TASK 6	FIGURE 4-2-9
INSTALLATION RESTORATION PROGRAM MASSACHUSETTS MILITARY RESERVATION
